Summary of Creek Survey/

St. Joseph Creek, Downers Grove, Illinois

TECHNICAL MEMORANDUM

Subject: Summary of Fieldwork Activities
Creek Walk/Creek Survey
Downers Grove, Illinois

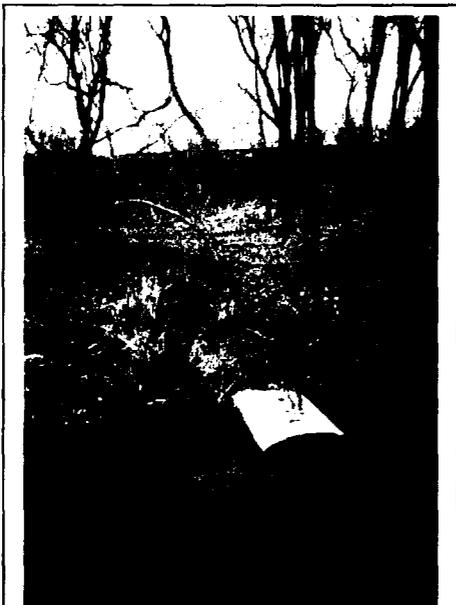
Location: Downers Grove/Lisle
Direction: N
Date: 12/4/01
Location/Photo: 6 1-24
Photo By: D. McGowan
Description: Outfall from previous photo, flowing water could be heard from pipe but no outflow was visible.

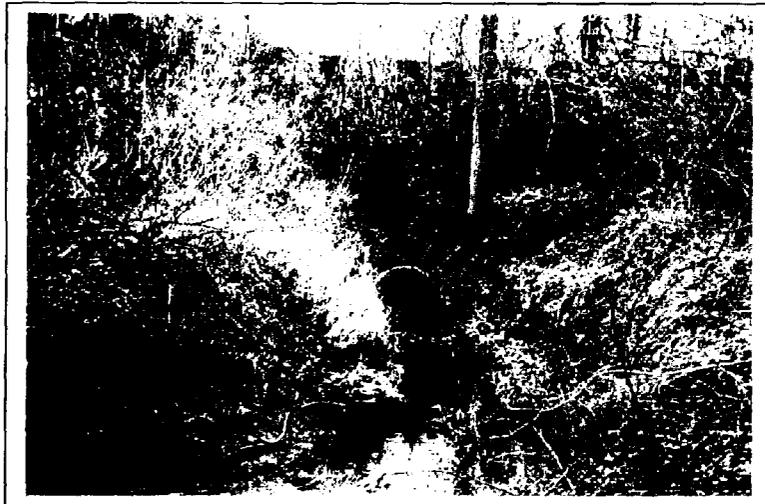
Location: Downers Grove/Lisle
Direction: S
Date: 12/4/01
Location/Photo: 8 2-22
Photo By: S. Nataraj
Description: Surface water drainage, pipe runs under railroad tracks and connects to drain mentioned in Photo #7. This stream runs east and then north on the northern side of the railroad tracks.

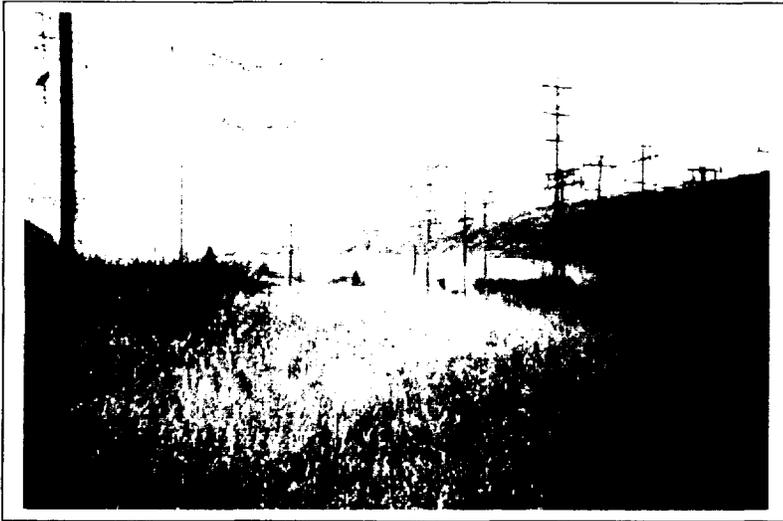
Description: Stream north of creek originates east of I-355 and flows through this small marsh. I-355 (center and right). ComEd transfer station (left).

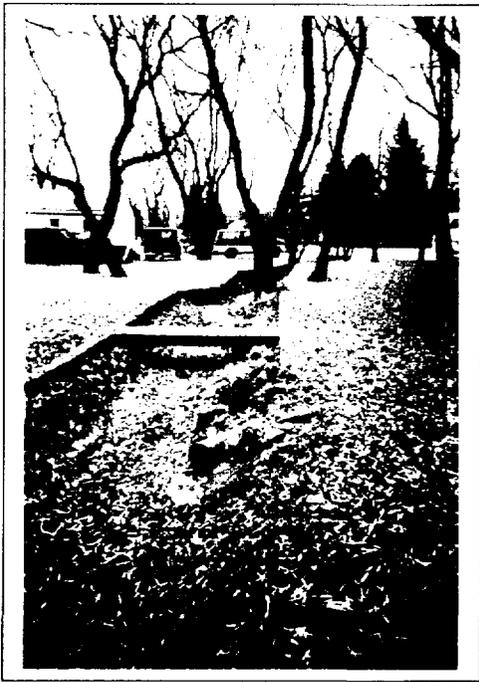
Description: Continuation of channel from Photo #12. Outfall pipes connect to drainage channel from residential properties.

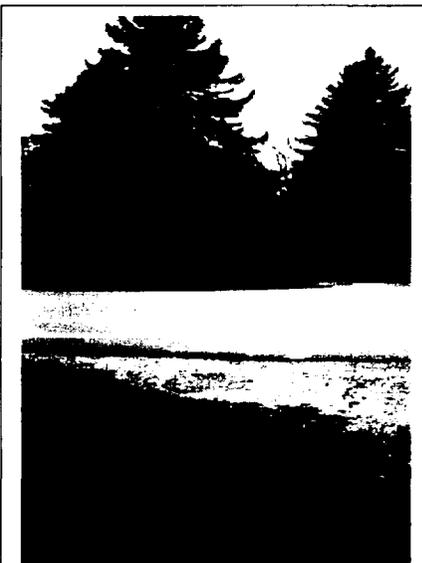
Description: Sanitary manhole (foreground); storm drain (background). Storm drain appears to connect to outfall pipe in Photo #14. Sanitary manhole does not appear to connect to outfall pipe in Photo #14.

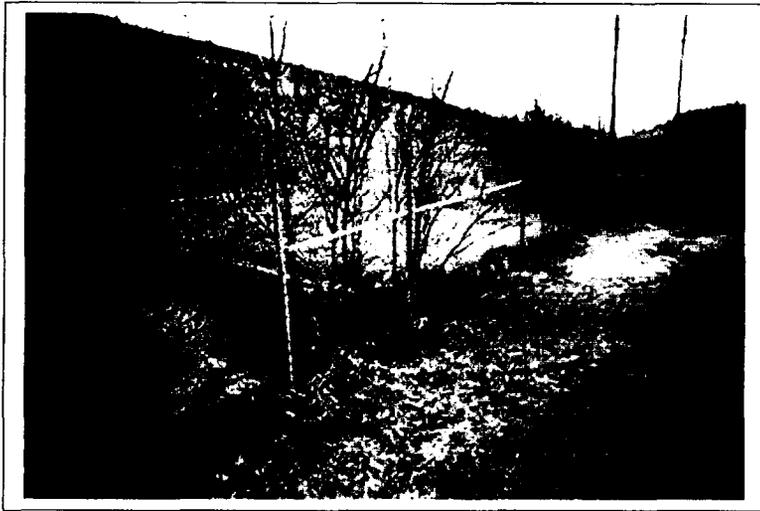
Location: Downers Grove/Lisle
Direction: SE
Date: 12/4/01
Location/Photo: 19 1-18
Photo By: D. McGowan
Description: Culvert under I-355, appears to drain into creek

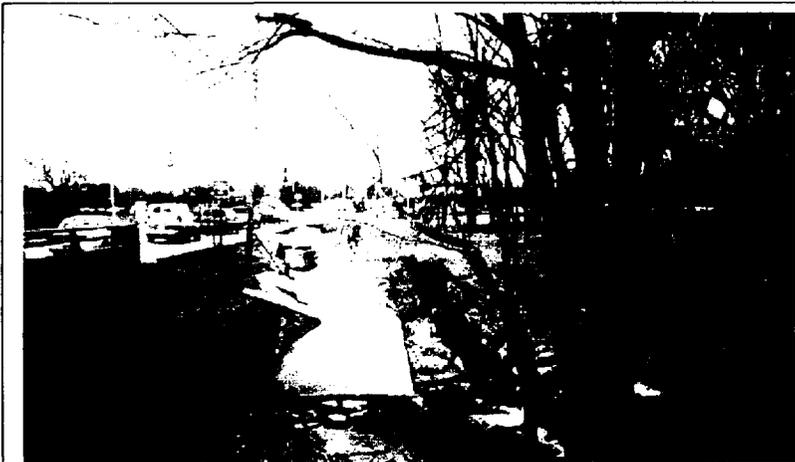
Location:	Downers Grove/Lisle
Direction:	N
Date:	12/4/01
Location/Photo:	65 4-10
Photo By:	D. McGowan
Description:	Belmont Ave. drainage culvert with manhole in background. Belmont Ave. bridge on left. sheet piling center to lower right.

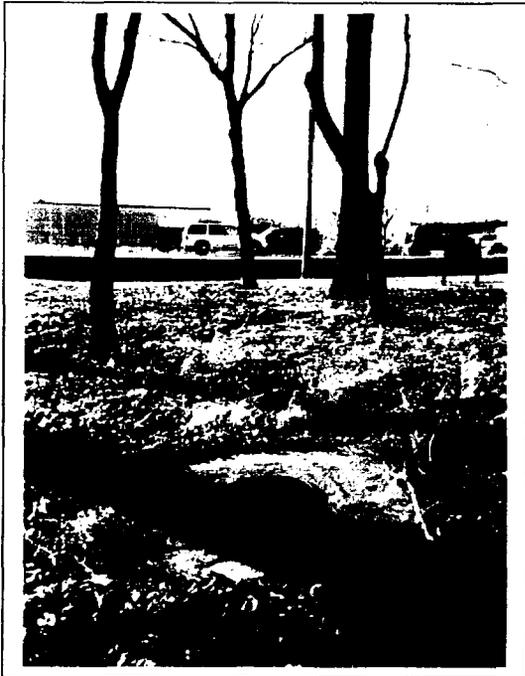
Description: Cistern in Downers Grove Park District property at the corner of Belmont Ave. and Curtiss St. One 4" pipe enters from the west.

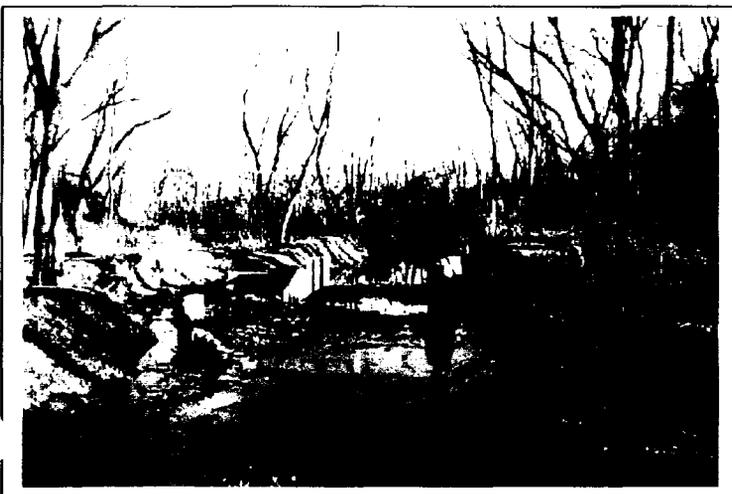
- Location 68: Remains of a concrete weir or bridge abutment.
- Location 69: Former site of Downers Grove Sewage Disposal Center.

Description: Remains of a concrete weir or bridge abutment associated with the old Downers Grove Sewage Disposal Center. Remains of old settling pond in center left (levee wall).
